MERRIMACK RIVER BASIN
MANCHESTER, NEW HAMPSHIRE

GOFFS FALLS DAM

NH 00292

PHASE I INSPECTION REPORT
NATIONAL DAM INSPECTION PROGRAM

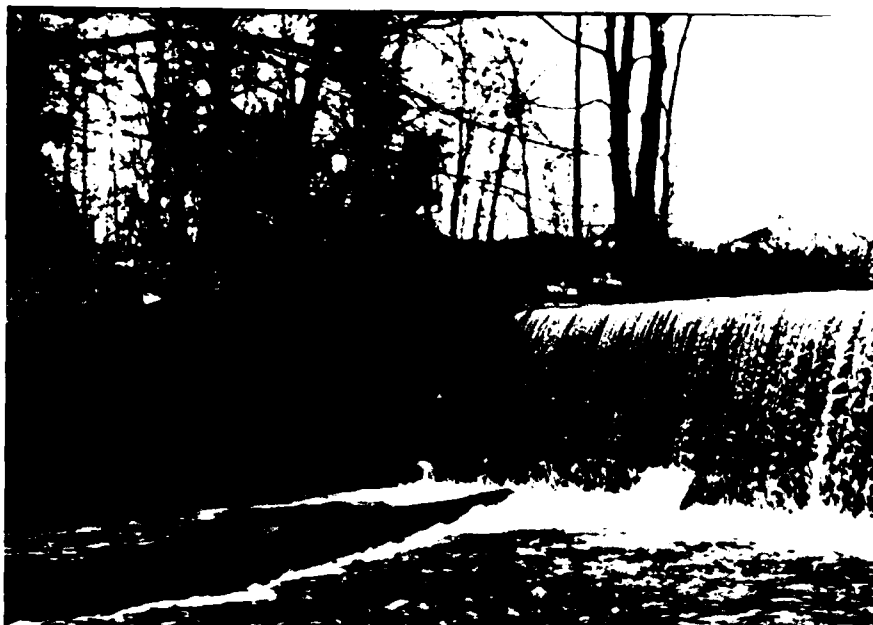
The upstream portion of the dry, split stone, masonry structure is in good condition. However, the downstream portion of this structure exhibits a void approximately 5 feet square. A sink hole was observed on the right bank immediately above this void. This hole was approximately 2 to 3 feet in diameter at the surface and is the result of fine material being washed out through the void in the wall below.

1. Right Abutment and End Wall - Note Undermined Section
Downstream of Spillway

It is recommended that the services of a qualified registered professional engineer be retained to evaluate the condition of the abandoned sluiceway and the undermined right end wall and sinkhole. The engineer should prepare recommendations and complete plans for rehabilitation of these structures. The owner should implement the findings of this evaluation.
